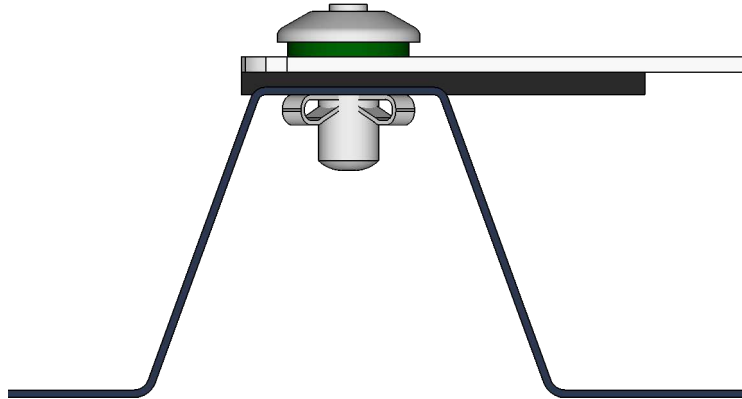
CORRECT

- The stem can be seen just above or just below the top (max 5mm below).
- The rivet has 'bulbed out' correctly.
- The rivet is sealed off correctly.
- It is recommended that silicone is applied if the rivet is 3mm or more below.
- If you are unsure, double check by looking at the seal under the rivet. If it is squashed and rivet feels tight then it has bulbed out correctly.

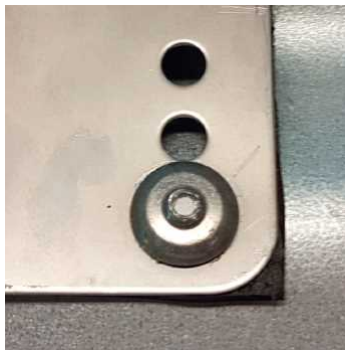
Bulb clashes with roof sheet

NOTE – The cause of this is often due to the 'bulb' not being able to expand out as it clashes with the side of the roof sheet. The rivet must go into the centre to avoid this happening
